## **CENTER HARBOR VILLAGE SCHOOLHOUSE**

**94 DANE ROAD, CENTER HARBOR, NH**

**EXISTING CONDITIONS REPORT & ASSESSMENT**

**8 JANUARY, 2018**

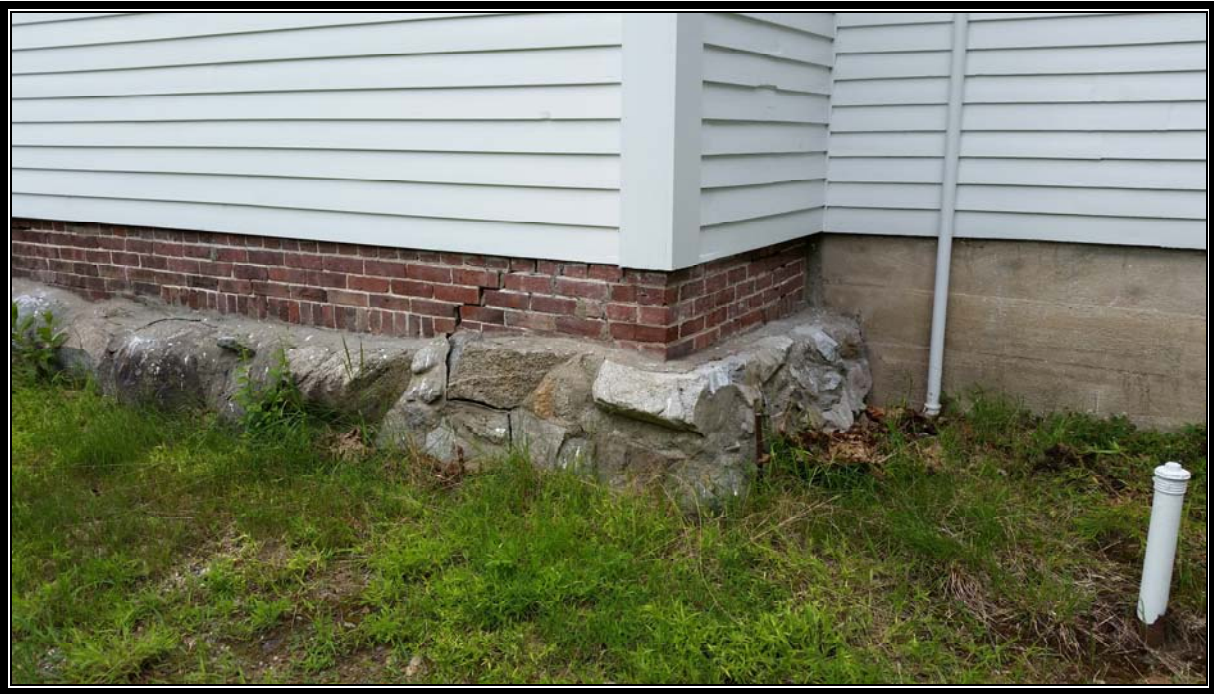
The combination stone / brick foundation walls show signs of settling and / or movement through the seasons. The north-east corner of the foundation should exhibit signs of deterioration.

Photo 3: Settling crack at corner of foundation.

▪ Structural - Repair north-east corner foundation of 1886-original block. Consider introduction of insulation under grade to exterior of corner and insulation to inside of corner to minimize future freeze-thaw induced movement.	\$3,840

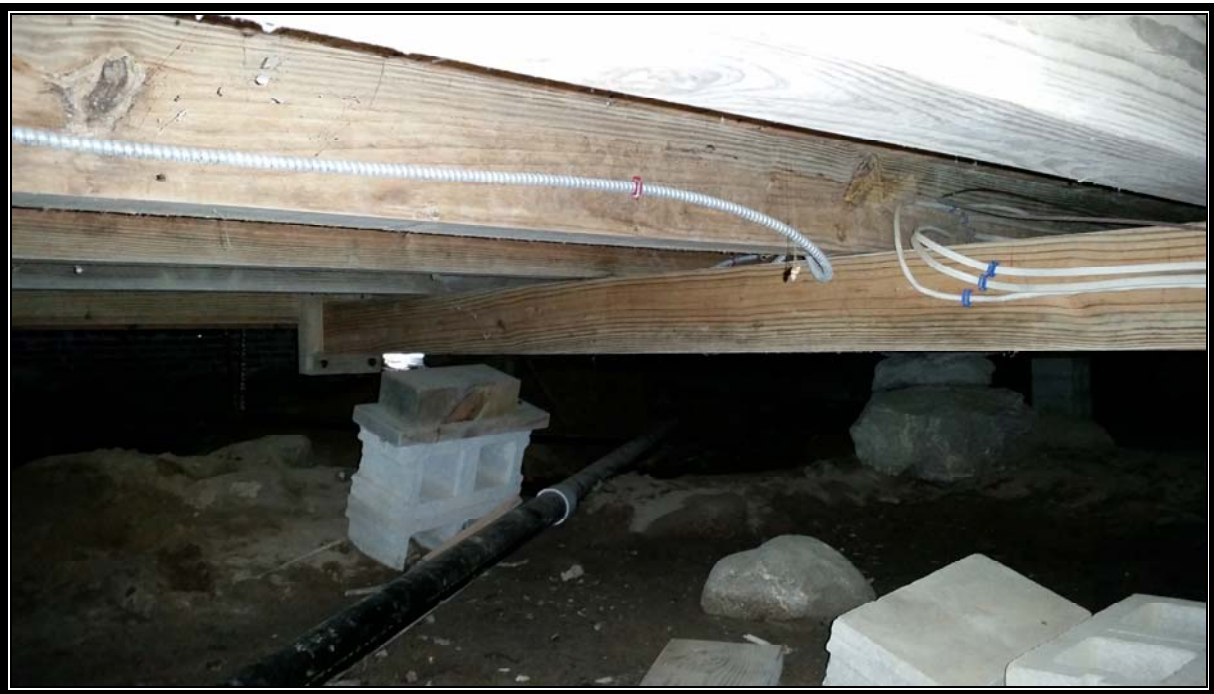
Photo 4: CMU pier not supporting beam.

▪ Structural - replace piled stone / block piers within crawl space of 1886-original block supporting the floor structure with suitable foundations and insulate to prevent cold weather heaving (concrete footings with pressure treated 6x6 stub columns anchored to footing and framing above).	\$7,680

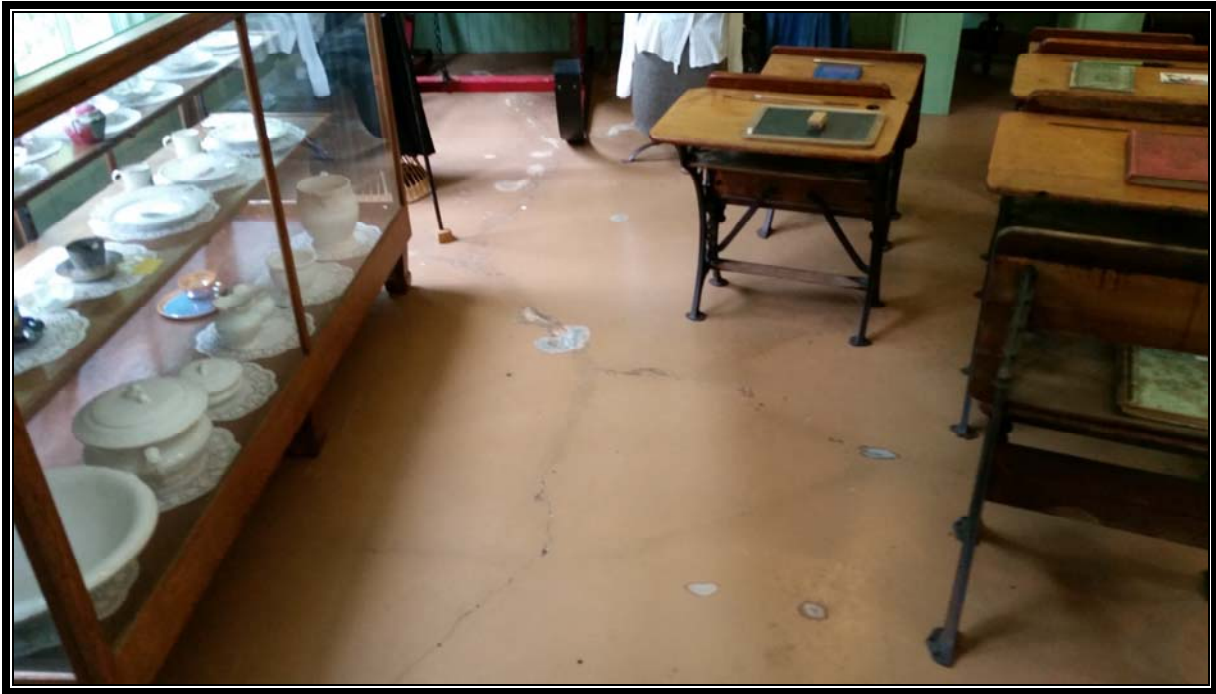
Approximately 8' of the floor is the same wood strip flooring on wood frame with the remaining 27' a painted concrete slab on grade. The floor slab does have numerous cracks showing some signs of settling, but appears not to be recent. Filling cracks and continued observation to insure no further movement is apparent is sufficient at this time.

Photo 5: Cracks in floor slab.

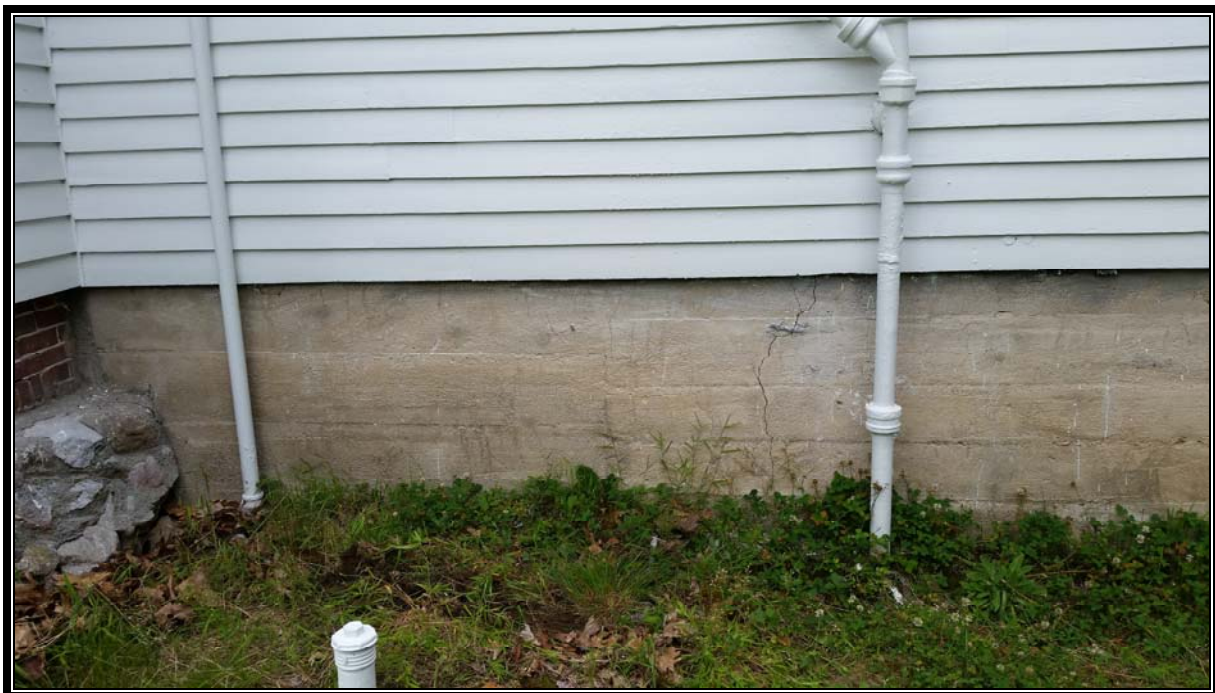
The foundation of these two blocks appears to be concrete block and some stone rubble foundation. There is also a section of concrete wall with board-formwork lines. There is some cracking in this wall which should be pointed / sealed and regularly observed for further movement / cracking.

Photo 6: Minor crack in concrete wall.

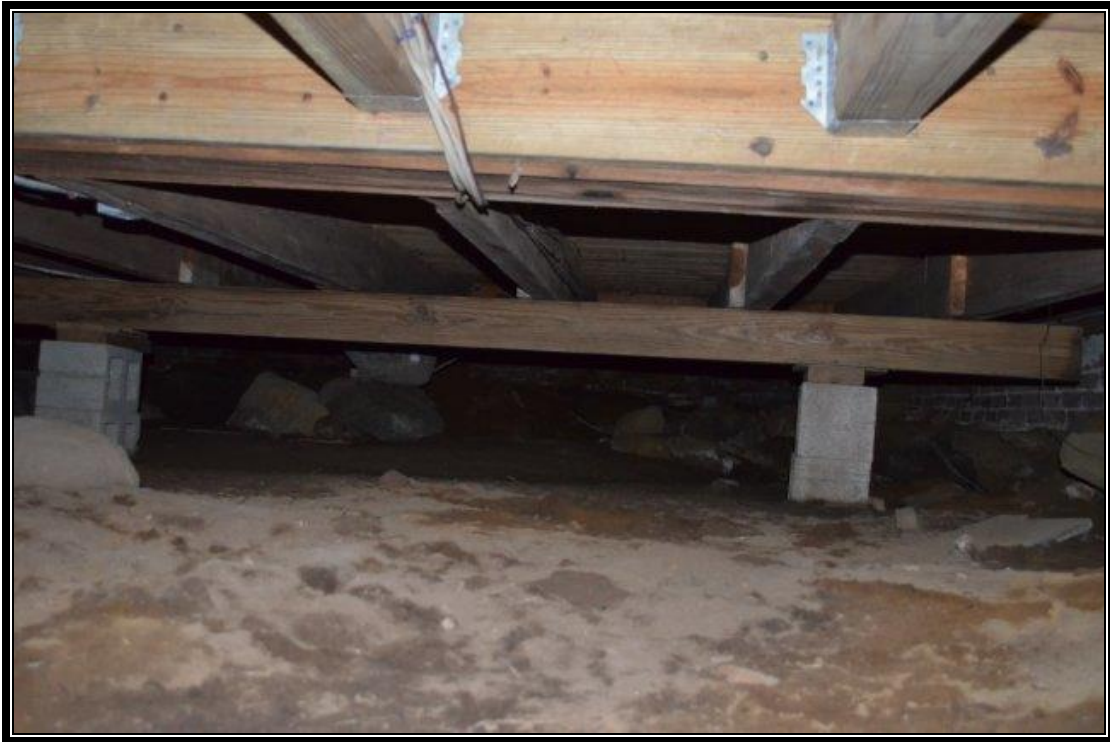
The original block is a wood framed floor with 2-1/2" - 3" strip wood flooring. The flooring and finish are in fair condition. There is concern with the north-west corner where an access hatch to the crawl space has been cut. Structural upgrades, some of which was undertaken in June 2016, appears to be comprised of new bearing points, sistering of floor joists, and mechanical fasteners. These upgrades to the floor system were effective with the exception of the stone / block piers, which have settled and/or collapsed and no longer support the framework. Significant bounce is noticeable in the floor and at that time it was not possible to close the hatch due to movement in the floor.

Photo 7: Repaired floor framing.

▪ Structural - Repair structural upgrades within crawl space of 1886-original block supporting floor structure, north corner (reconnect structural members, fasten with through-bolts and/or galv connectors)	\$6,400

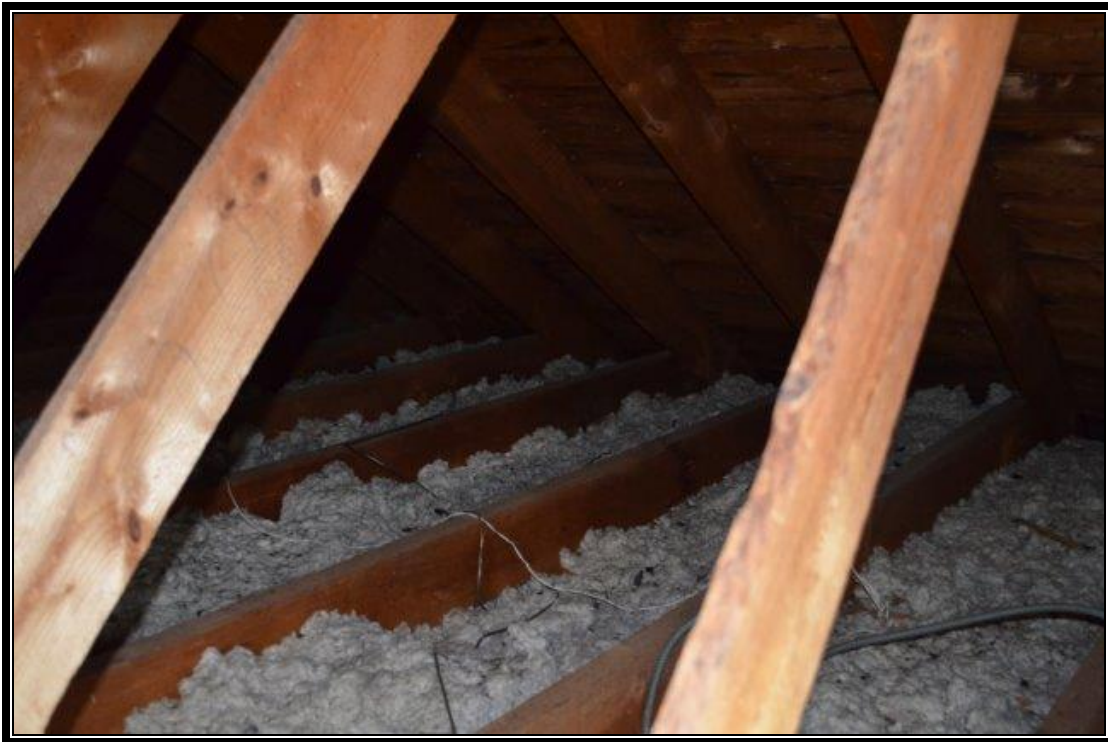
Photo 8: Roof truss.

▪ Structural - Repair cut bottom chord of 1886-original block roof truss	\$600
▪ Structural - Limiting occupants to maximum occupant load has been suggested as impractical due to needs of Historical Society meeting and potential functions. Other options would be to reduce spans of floor system by the introduction of further foundation / footing points and suitable columns. Further design work would be required to confirm extent require to adequately increase floor structure for increase occupant load.	<i>requires further detailing to establish cost</i>

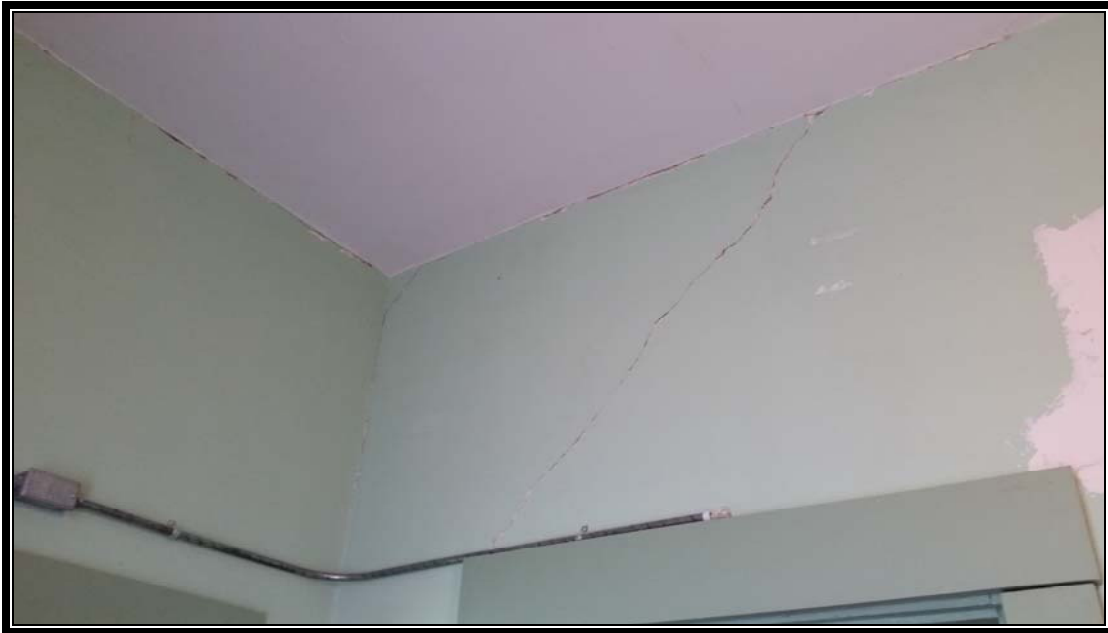
Photo 9: Cracks in the plaster on the inside of the front walls.

RECOMMENDATIONS	TERTIARY PRIORITY
<i>recommendation</i>	<i>estimate of probable cost</i>
▪ Finish – Repair cracking in plaster / sheetrock walls were evident. Monitor areas for additional cracking which would indicate further movement in structure.	\$2,560

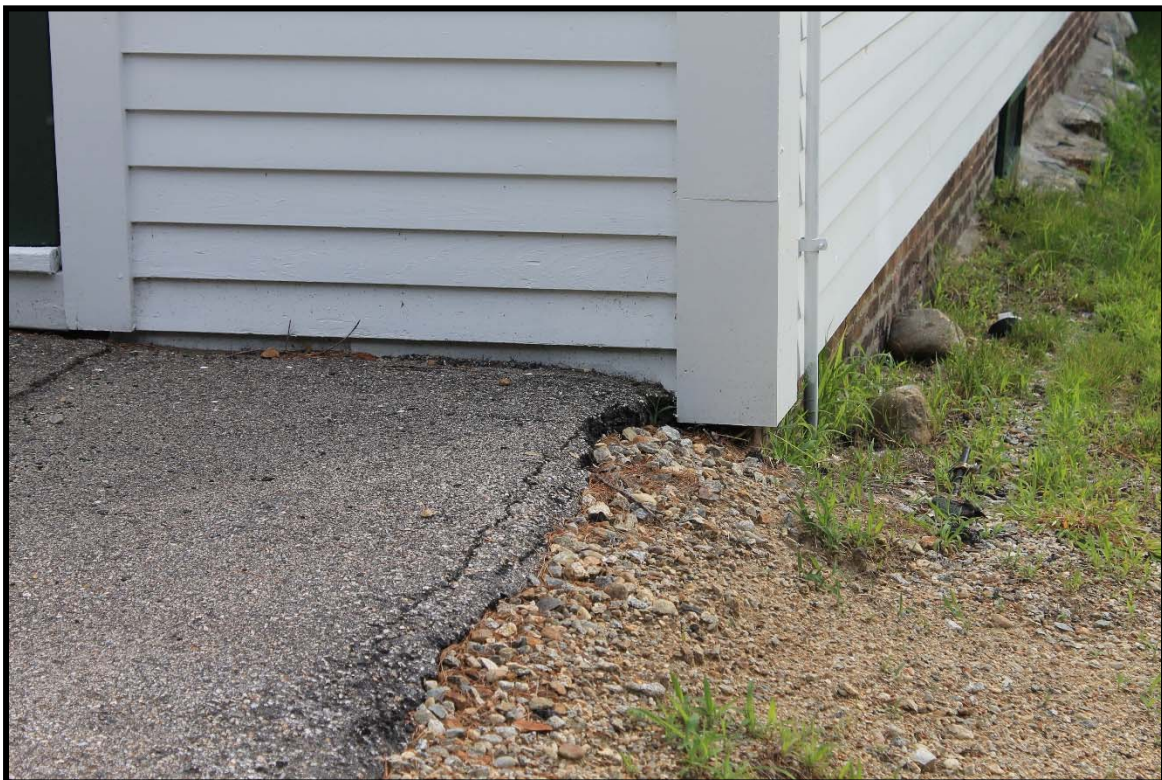
More areas of the siding are less than 4" from grade and consideration should be given to scrape back grade and create a minimum of 8" clear grade to wood. Generally, the finishes are in acceptable condition, surprisingly less so than the older original block, but adequate. Roof finish is in considerably better condition than the original block, but is still showing signs of age and will require replacement within five years.

Image Exterior Detail 002 – Typical Grade Condition at 1886 Schoolhouse

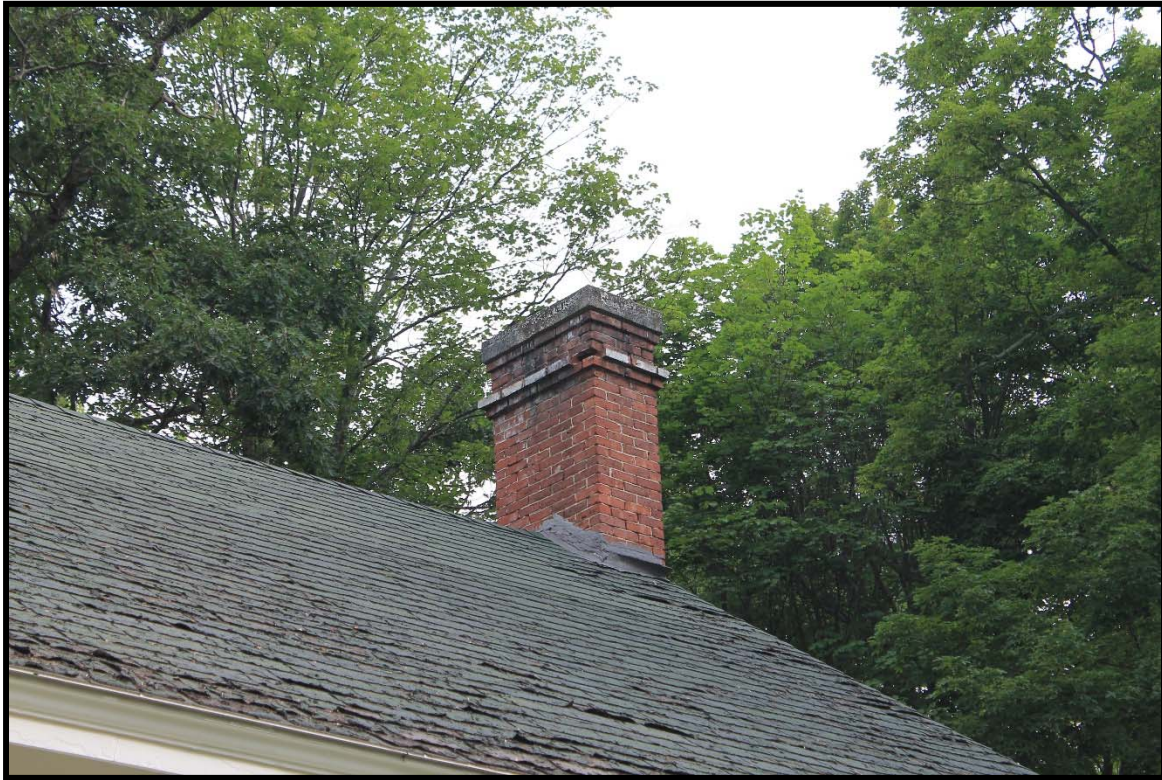
The brick chimney appears to be in stable condition. However, some loose brick has been observed, as well as at least one occurrence of dislodged brick, and further detailed inspection is recommended.

Image Exterior Detail 009 – Chimney at rear of 1886 Schoolhouse

▪ Masonry chimney – Repair / repoint all exterior brickwork to chimney, seal with suitable application. <i>Note: age and make-up of existing mortar should be confirmed with specialist consultant to insure appropriate material usage.</i>	\$5,000 <i>+ consultant</i>

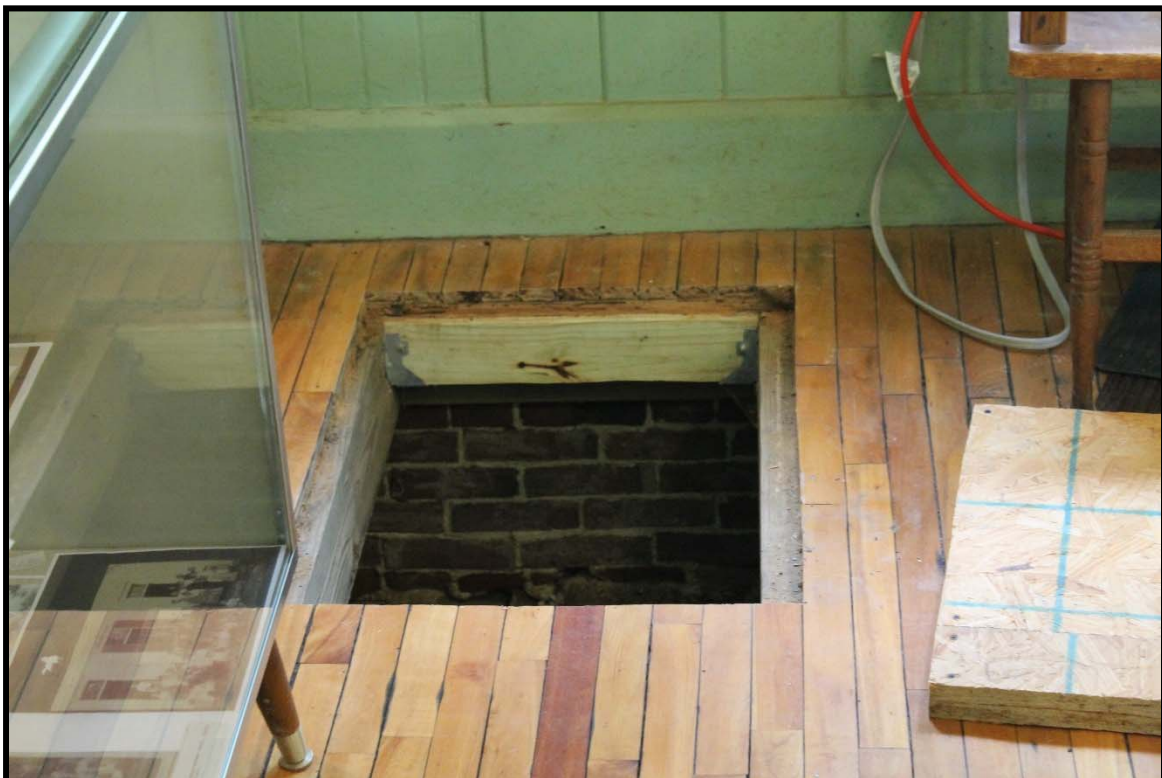
Image Interior Detail 004 – Crawl Space Access Hatch at 1886 Schoolhouse

▪ Finish -Reconstruct 1886 Original block crawl space access hatch utilizing original strip flooring removed when hatch was cut.	\$1,280
▪ Roofing - Replace built-up roof finish over kitchen/toilet block prior to failure. Monitor for roof leaks and address when budget permits. Include head-wall and side-wall flashing, keeping wall finish 4"-6", minimum, above roof finish and lap flashing behind siding / over roofing.	\$1,200
