## **CENTER HARBOR VILLAGE SCHOOLHOUSE**

**94 DANE ROAD, CENTER HARBOR, NH**

**EXISTING CONDITIONS REPORT & ASSESSMENT**

**8 JANUARY, 2018**

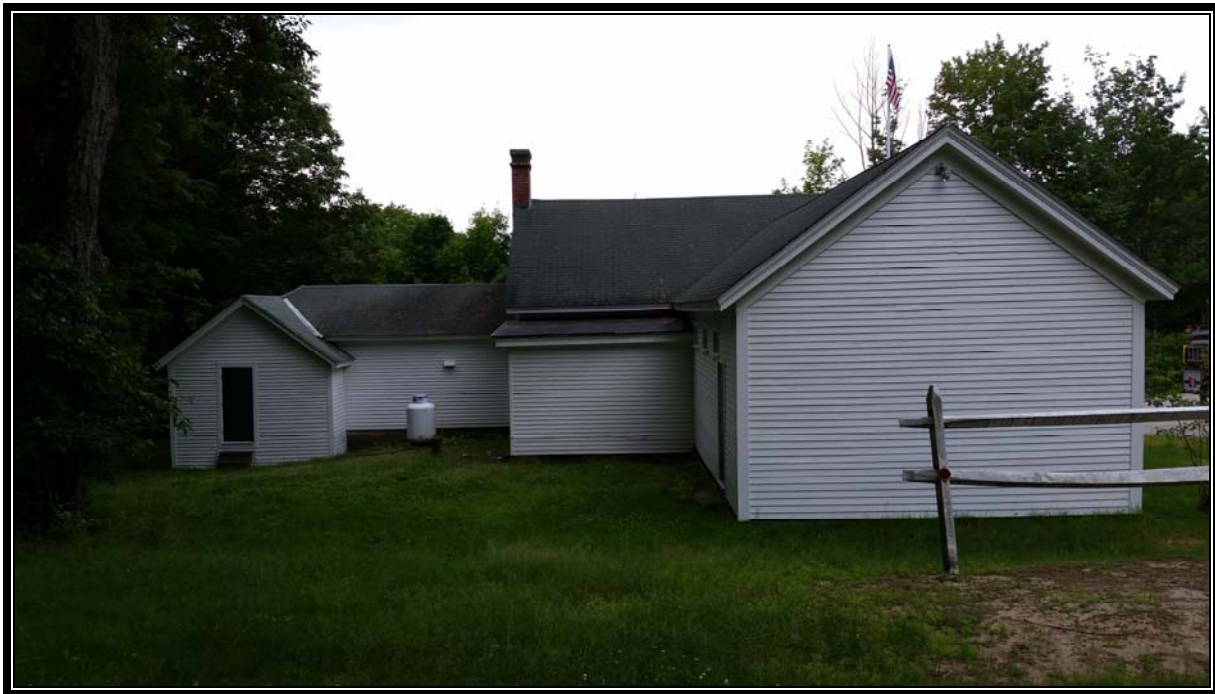
Photo 2: Looking south at the building.

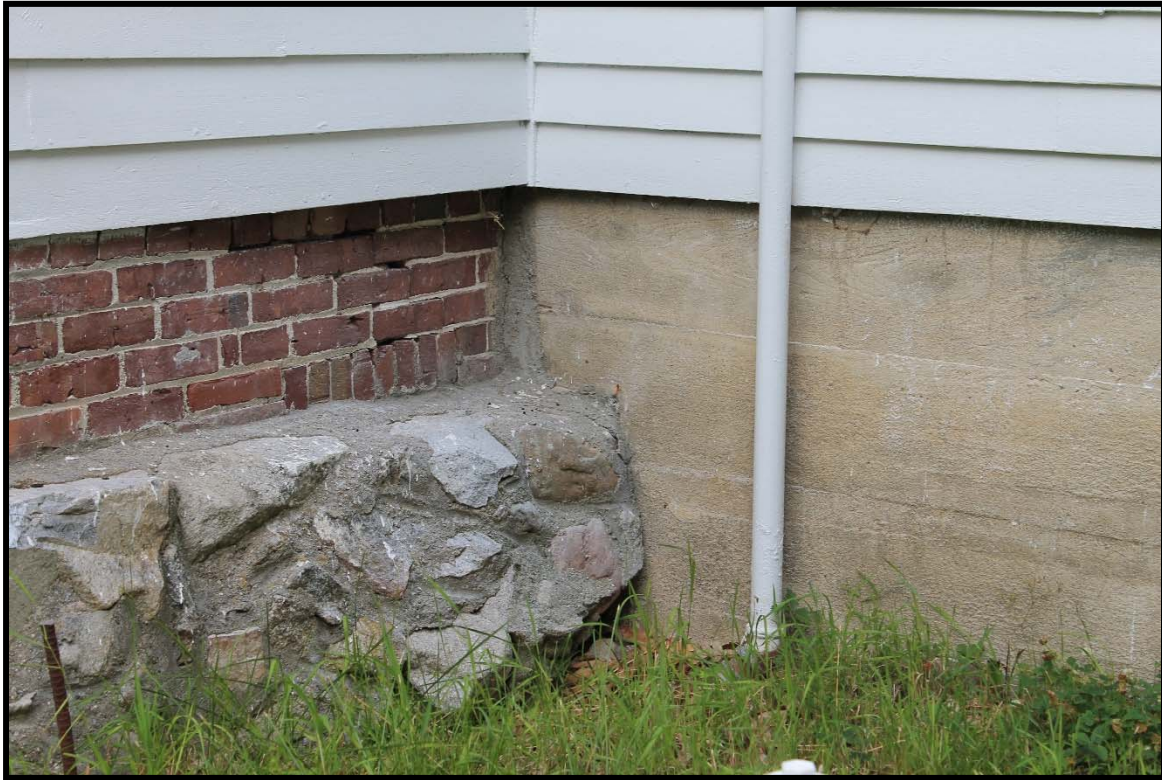
The combination stone / brick foundation walls show signs of settling and / or movement through the seasons. The north-east corner of the foundation should exhibit signs of deterioration.

Image Exterior Detail 001 – Inside Corner of Foundation at 1886 Schoolhouse and 1919 Kitchen Addition

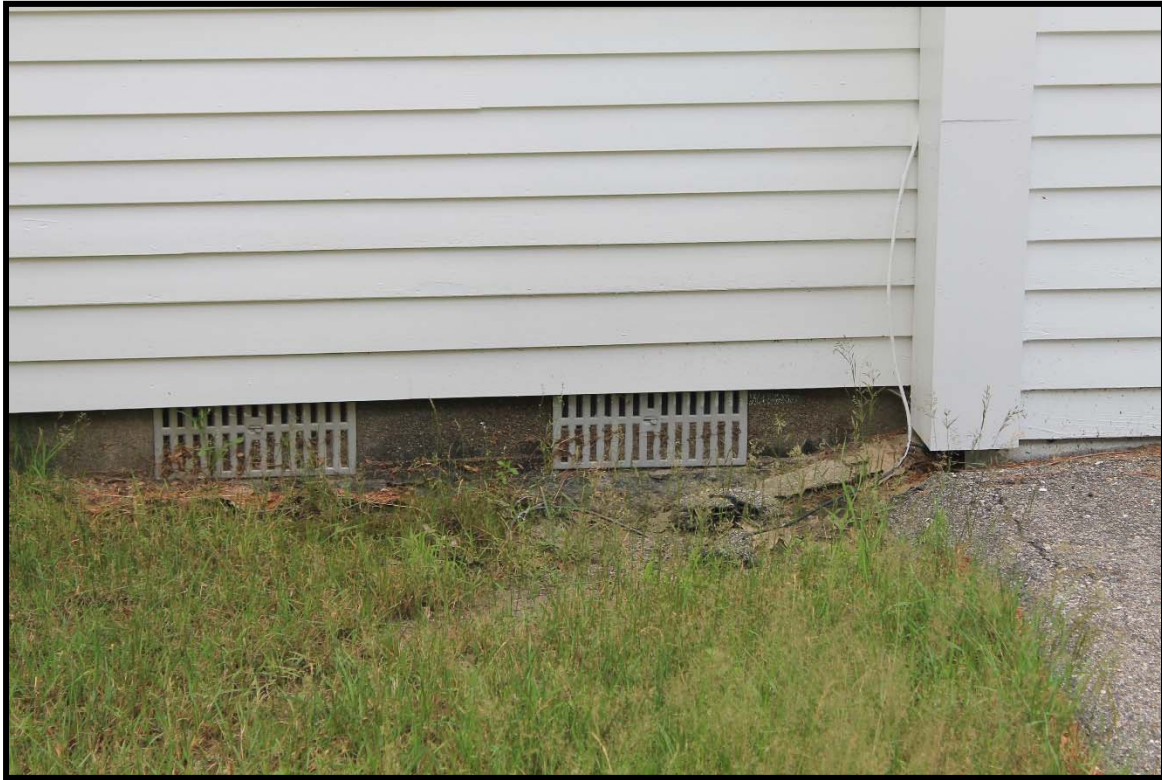
Image Exterior Detail 003 – Crawl Space Venting at 1902 / 29 Addition

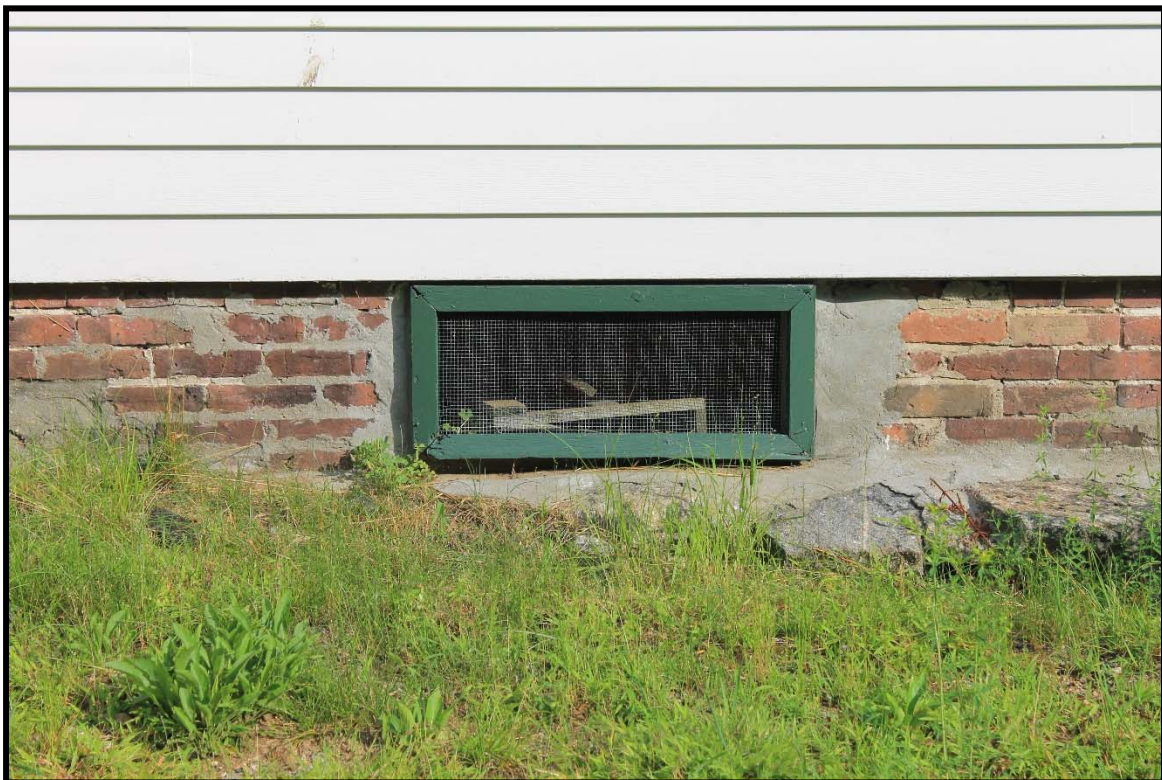
Image Exterior Detail 004 – Crawl Space Venting at 1886 Schoolhouse

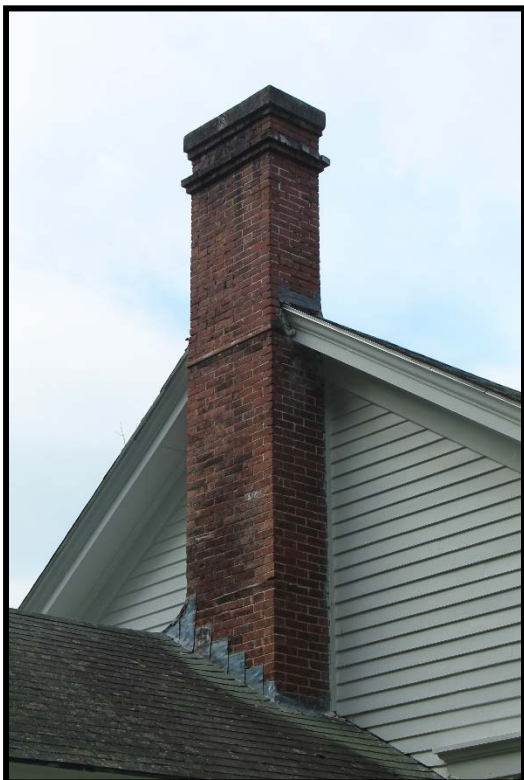
The brick chimney appears to be in stable condition. However, some loose brick has been observed, as well as at least one occurrence of dislodged brick, and further detailed inspection is recommended.

Image Exterior Detail 010 – Chimney at Rear of 1886 Schoolhouse

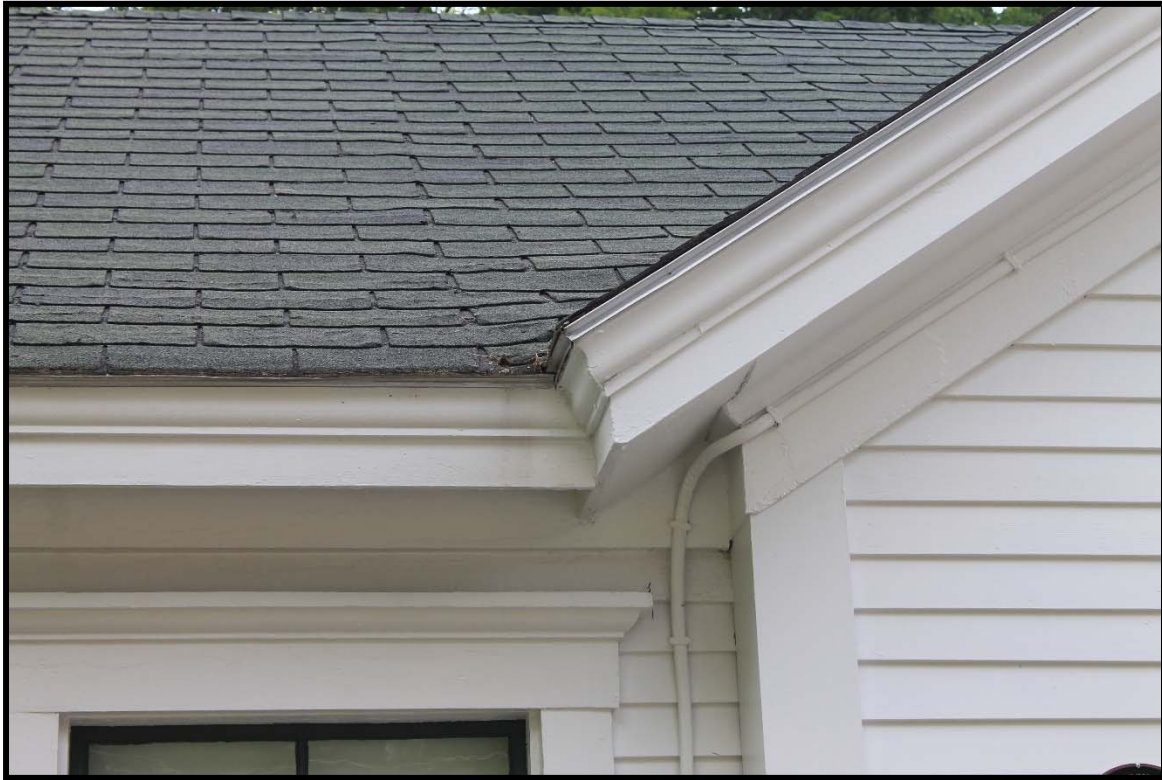
Image Exterior Detail 011 – Typical Eave Condition

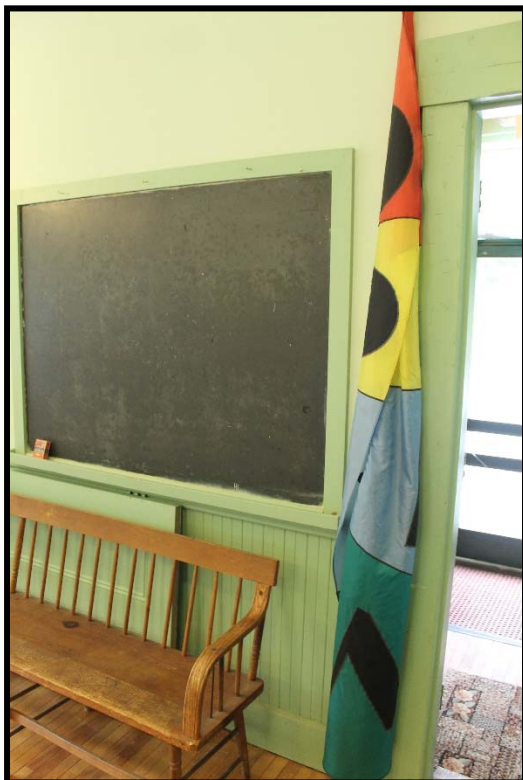
Image Interior Detail 002 – Typical Interior Wall Finish at 1886 Schoolhouse

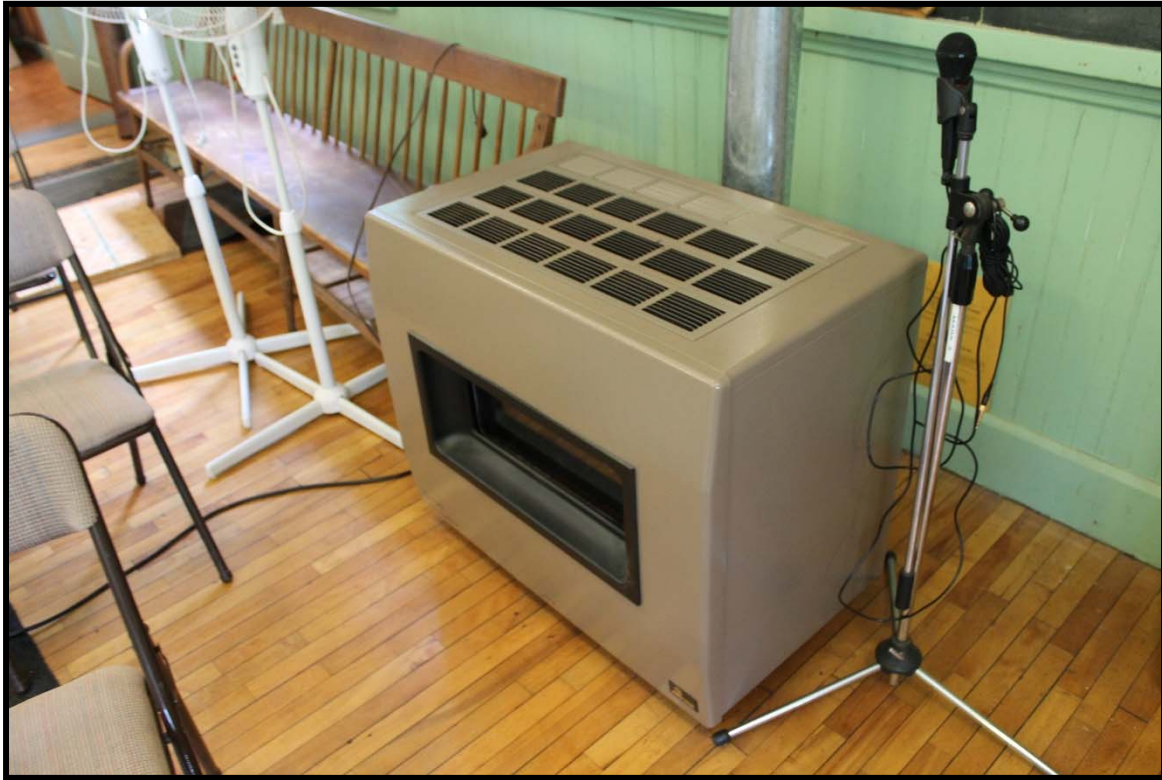
Image Interior Detail 003 – Furnace in 1886 Schoolhouse

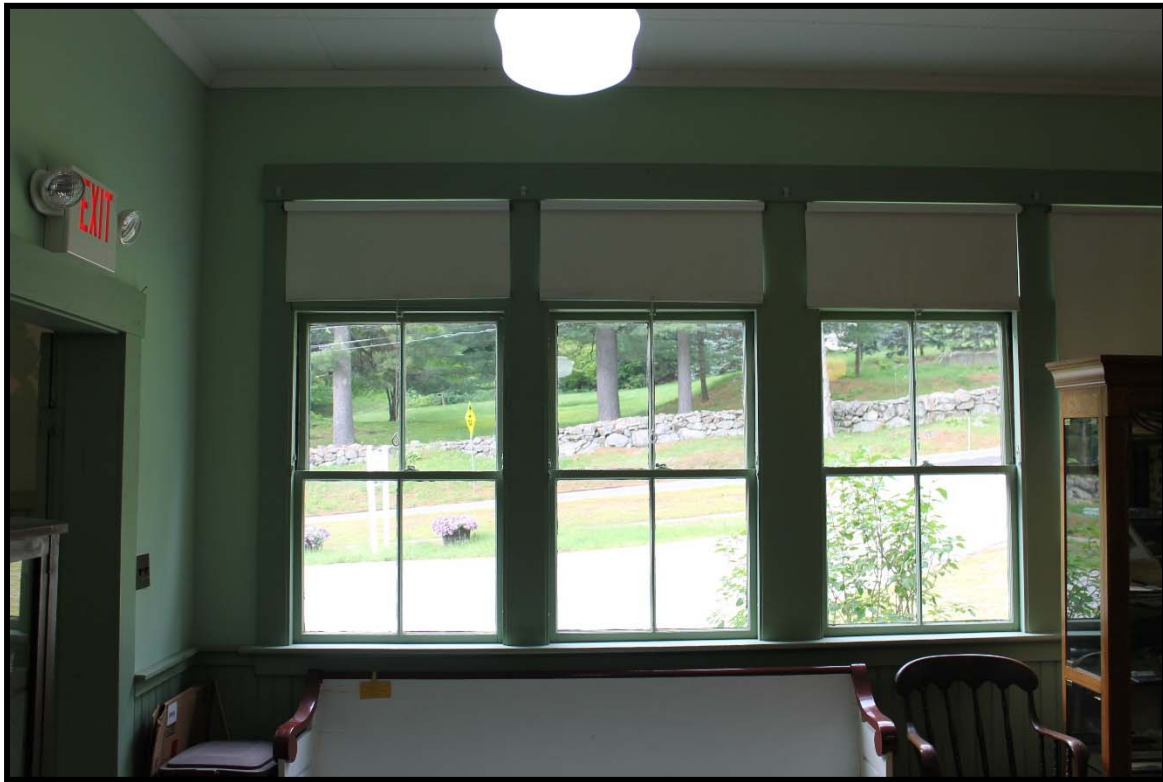
Image Interior Detail 007 – Window Interior at 1902 / 29 Classroom Addition

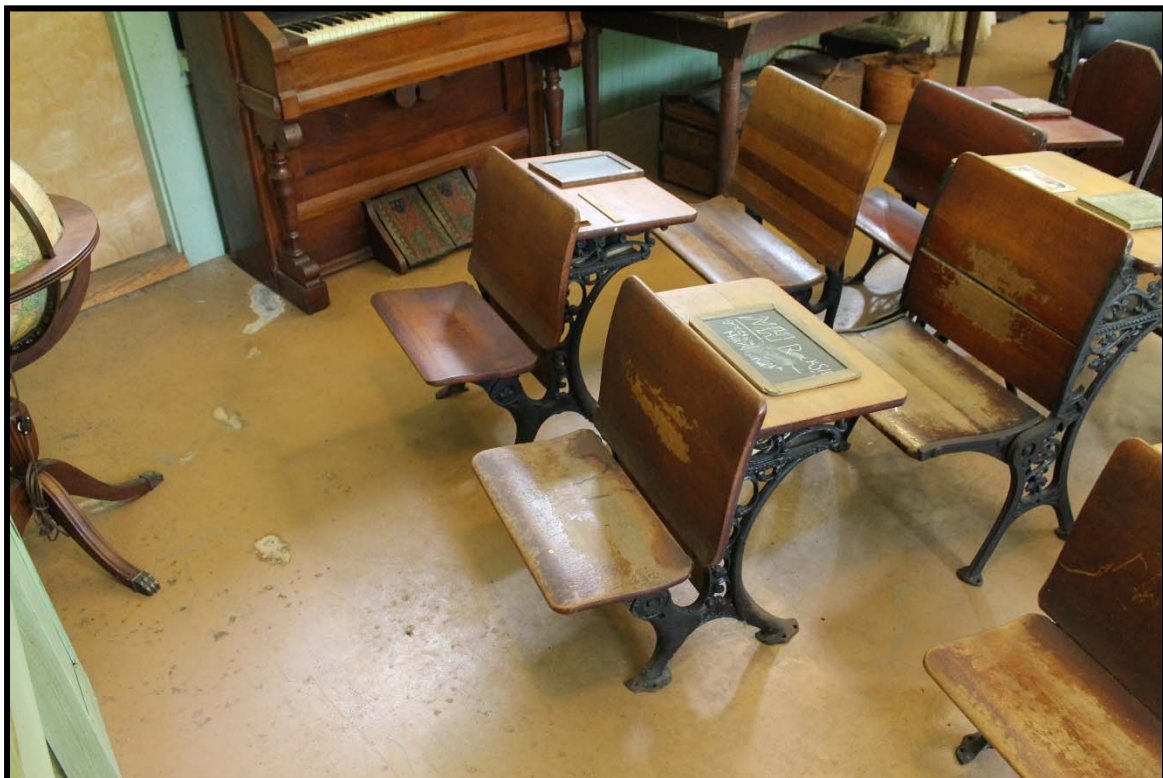
Image Interior Detail 008 – Typical Desks at 1902 / 29 Addition

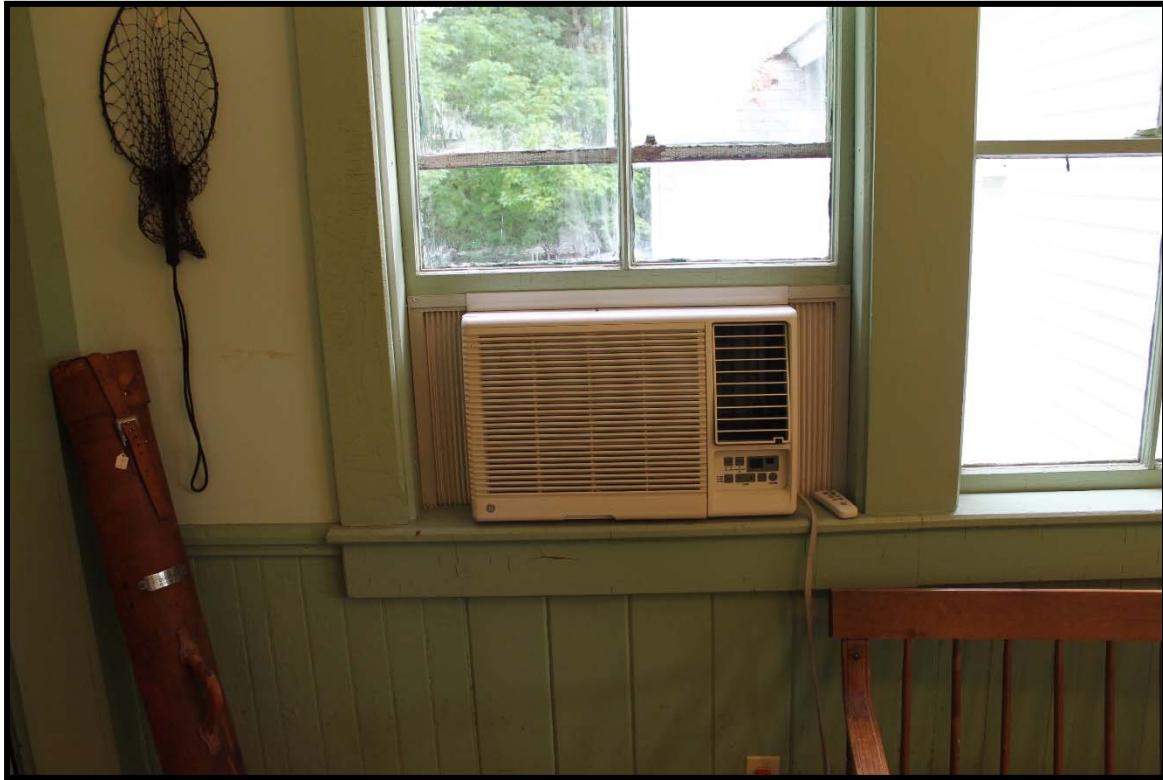
Image Interior Detail 009 – Window Air Conditioner Installed.

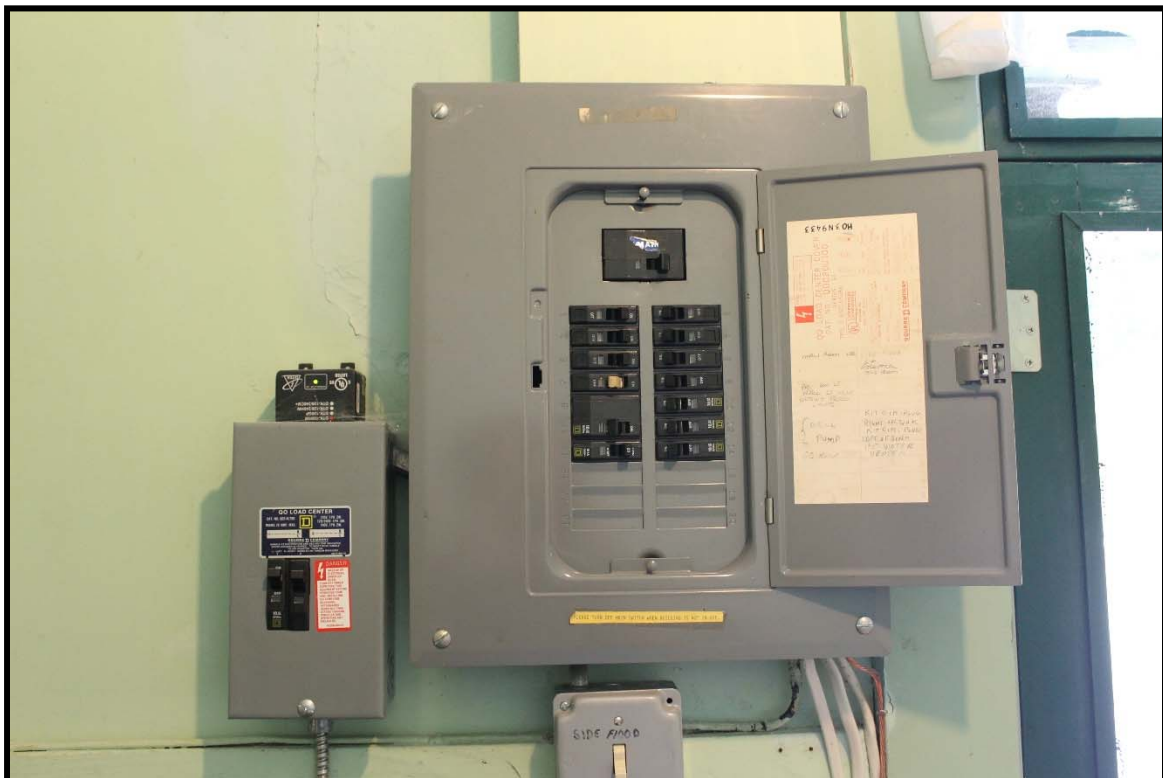
Image Interior Detail 010 – Existing Electrical Panel

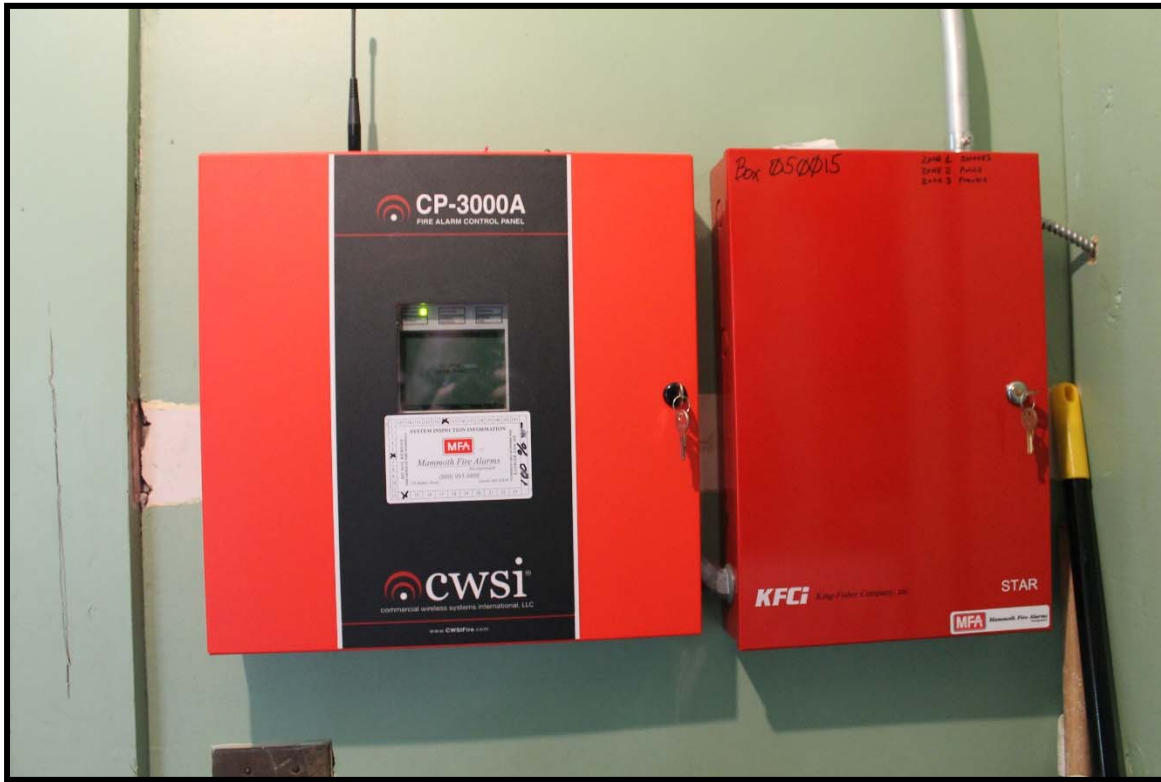
Image Interior Detail 011 – Existing Alarm Panel

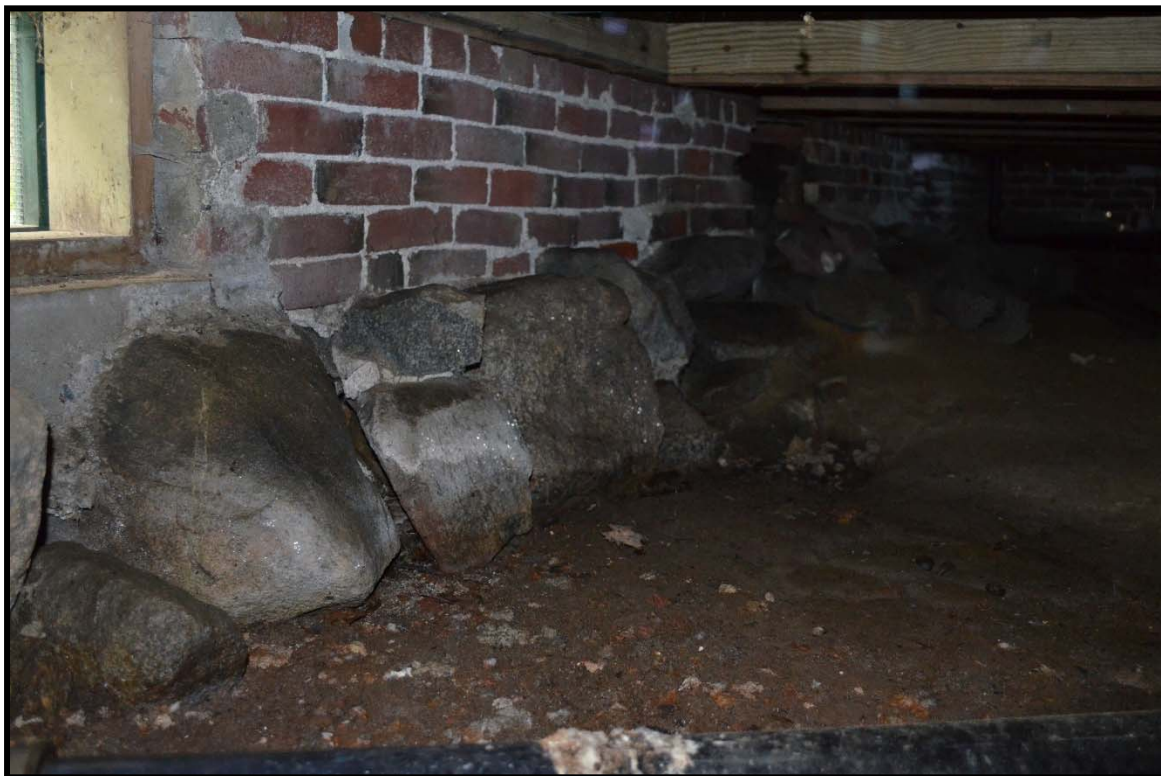
Image Interior Detail 012 – Crawl Space under 1886 Schoolhouse

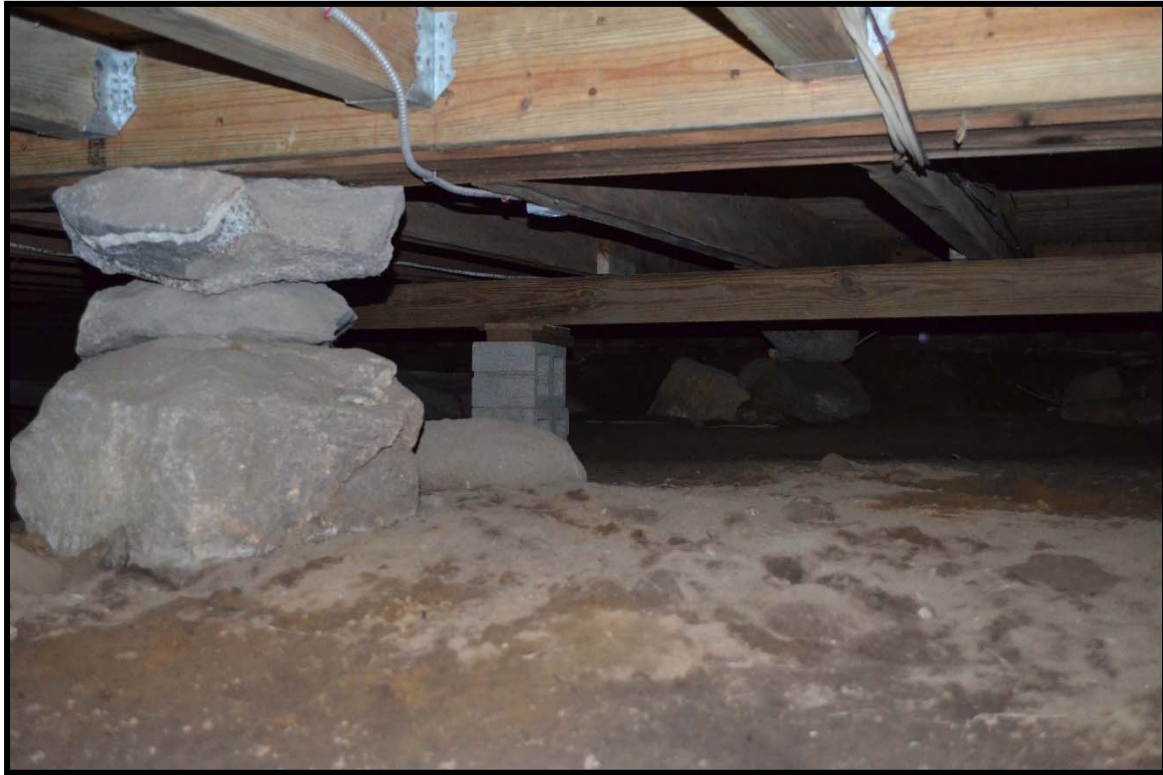
Image Interior Detail 013 - Crawl Space under 1886 Schoolhouse

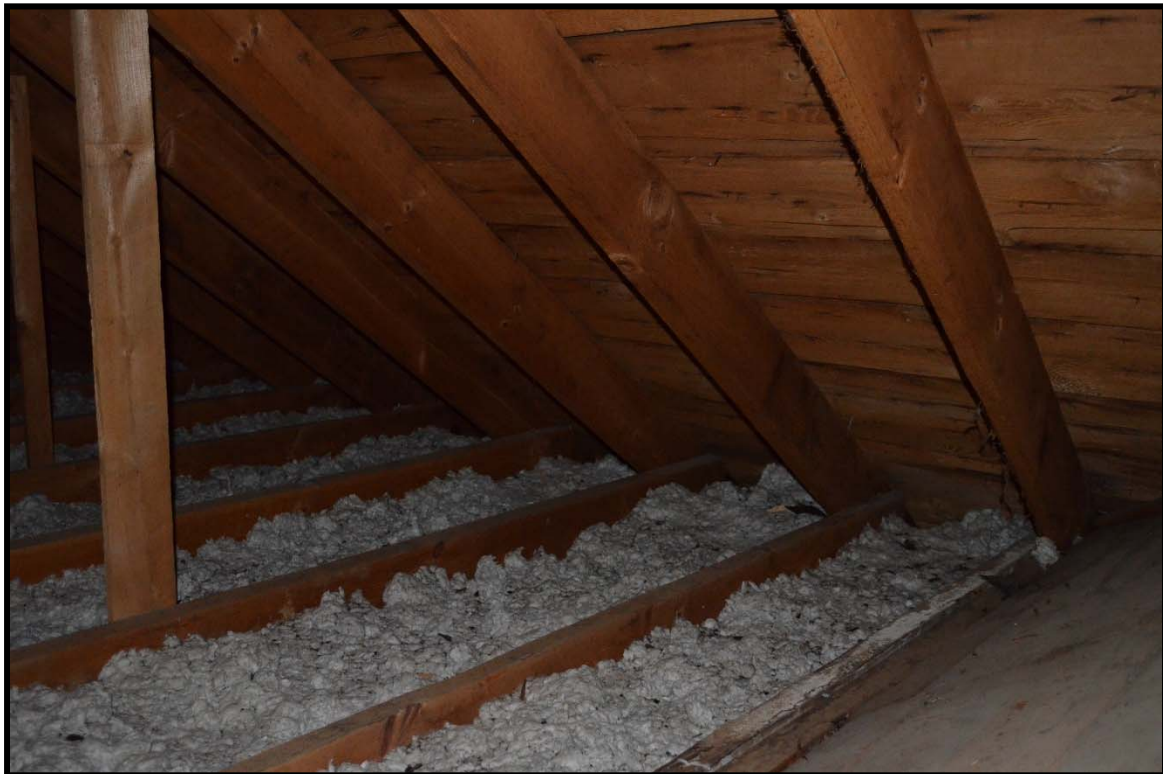
Image Interior Detail 014 – Attic above 1886 Schoolhouse

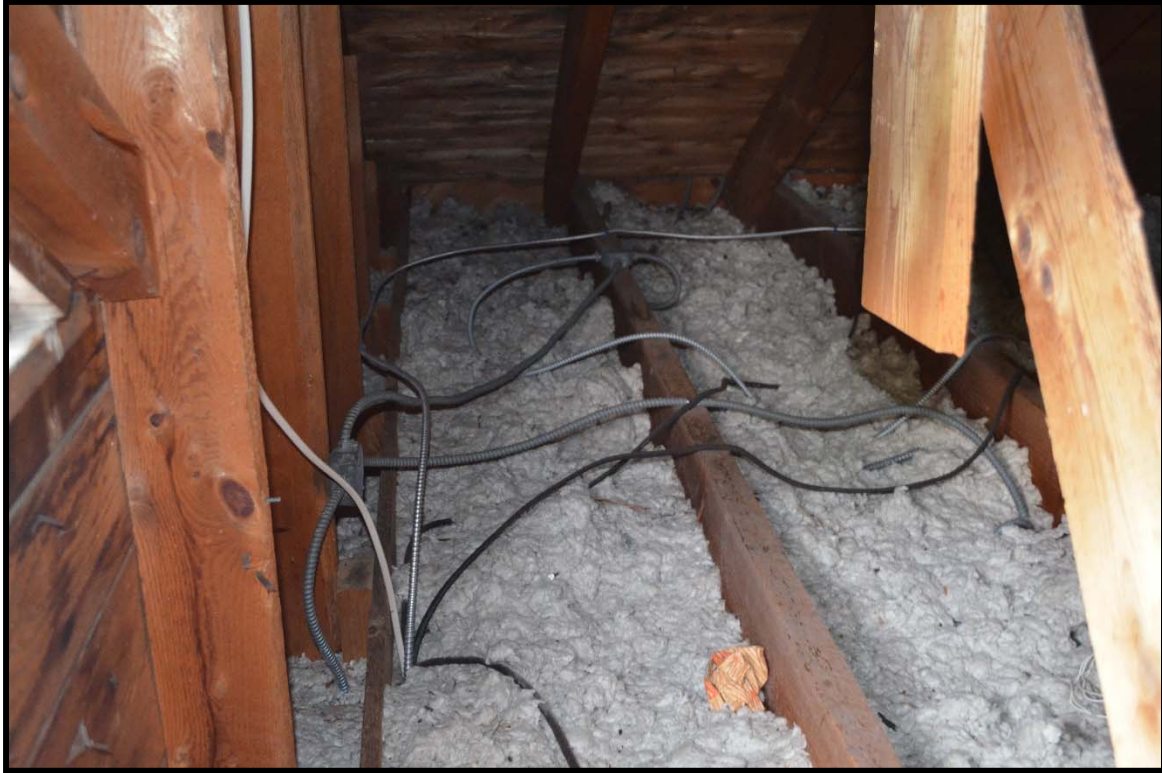
Image Interior Detail 015 - Attic above 1886 Schoolhouse
